Spacecraft Materials Studies on The Aerospace Corporation Tray on EOIM-III

15 August 1994

A passive tray was flown on the Effects of Oxygen Interaction with Materials experiment on STS-46 (EOIM-III) with 82 samples from The Aerospace Corporation. A variety of advanced materials related to potential uses on future spacecraft were included for evaluation representing optical coatings, lubricants, polymers, composites, carbon-carbon composite protective coatings, graphite protective coatings, thermal-control materials, and some samples of current materials. An overview of the available results from the investigations of these materials is presented.

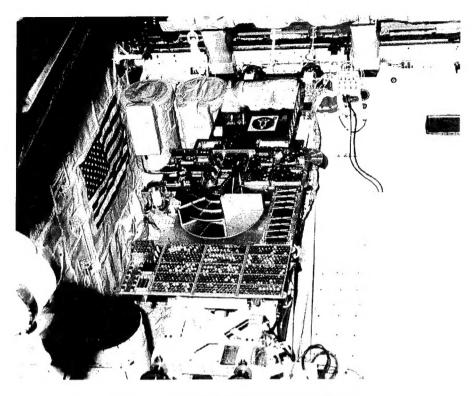
Figure 2. EOIM-III in the STS-46 shuttle bay.

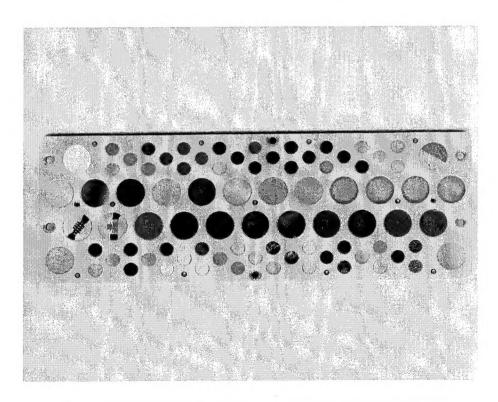
Figure 3. Post-flight ambient temperature Aerospace tray on EOIM-III.

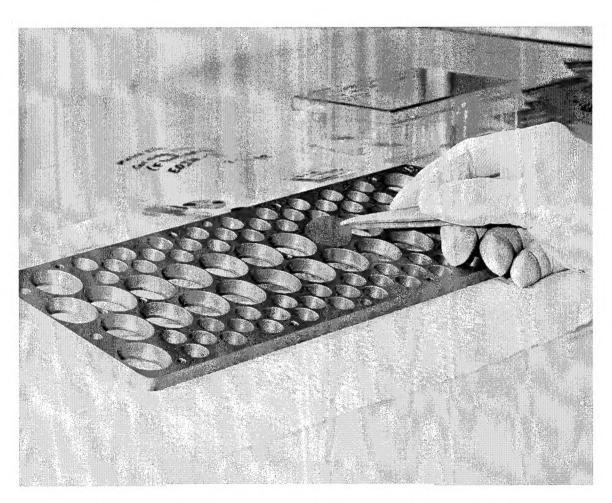
Figure 4. Sample loading on the Aerospace Tray on EOIM-III tray. Samples were loaded from the back side with a beveled retainer at the front of the tray.

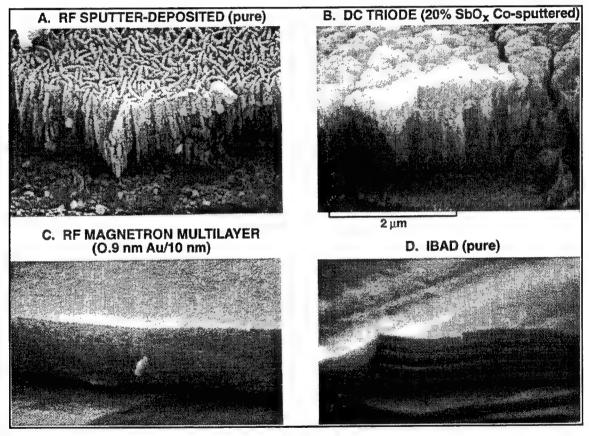
Figure 5. SEM micrographs showing the cross-sectional morphologies of various MoS₂ films, after brale indentation, prepared by (a) rf sputtering; (b) dc triode sputtering with 20% SbO_x codeposited; (c) rf magnetron sputtered MoS₂/Au-20%Pd multilayer films (the Au-20%Pd layers are 0.9 nm thick having a repeat periodicity of 10 nm); (d) IBAD (deposition was periodically modulated with increased sulfur, which appears to form steps during fracture). The pure, sputtered films have a porous microstructure and edge plane preferred orientation parallel to the surface. The use of dopants, multilayers, or ion beams densifies film morphology and promotes disordered or basal-plane texturing as opposed to edge-plane texturing.

A series of MoS₂ films (deposited onto 440C steel) having different microstructures were flown on EOIM-III on several trays. The films were characterized structurally (SEM), chemically (AES/XPS), and tribologically (sliding friction coefficients in air and in UHV) by Sandia (PI: Michael T. Dugger). Descriptions of the films are listed in Table 6. All films had a total thickness of 1 µm. Duplicate samples were flown so that for each film type, one sample was exposed to AO, and one was shielded (flight control). Additional ground-control samples were prepared and characterized. Post-flight analyses of these films are still in progress, though there are some preliminary data available. Of the newer films, microscopy has shown that the Ni-multilayer films exposed to flight AO have developed cracks and delaminated regions. The Au-20%Pd multilayer, SbOx-cosputtered, and IBAD films did not have cracks or delaminated regions. Postflight sliding tests in air have been conducted on these dense films. In the AO exposed regions, initial friction coefficients 3-4x above baseline were observed for the first 10 to 100 cycles before friction values dropped to baseline levels. The data suggest that a thin layer of MoO3 had formed, which was quickly removed in sliding; this is consistent with the ground test AO experiments.⁵ From a design viewpoint, the preliminary data indicate that the Ni-multilayer films should be avoided for use as a lubricant on AO-exposed mechanisms because of coating fracture/delamination. The other dense microstructures may be more suitable for such mechanisms if the devices are not used continuously, although designers should anticipate higher initial friction coefficients after periods of inaction on exposed mechanisms if these lubricants are used. If the mechanisms are used continuously, these lubricants would appear to require shielding from AO to avoid continual oxide formation that would accelerate wear.

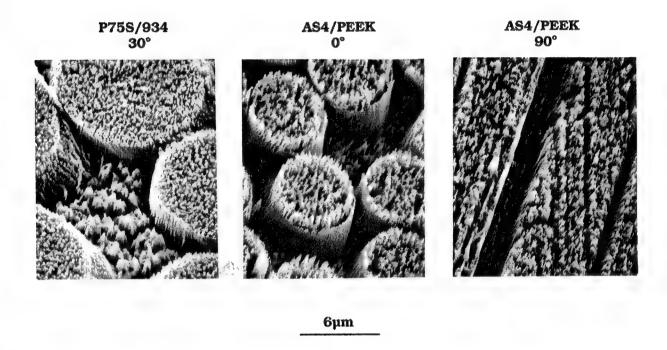
Several observations were made from SEMs of the erosion surfaces as shown in Figure 6. The 934 epoxy and PEEK thermoplastic matrix erosion rates were significantly higher than those for the P75S and AS4 graphite fiber, respectively. The erosion morphologies were similar for the two polymer matrices. Similar erosion features were observed on the ends of the AS4 fibers, perpendicular to the fiber axis, and on the sides of the fibers, parallel to the fiber axis. Although not shown in Figure 6, the P75S fiber also showed no orientation dependence for the erosion morphology. Finally, the P75S fiber eroded with a more uniform, finer structure than the AS4 fiber. This is contrary to the result anticipated from LDEF observations. Unfortunately, this experiment did not enable interpretation of LDEF atomic-oxygen erosion morphologies.

Figure 6. Scanning electron micrographs of atomic-oxygen erosion features for graphite-fiber-reinforced polymer matrix composites flown on EOIM-III. The fiber axis orientation relative to the atomic-oxygen velocity vector is shown for each micrograph.
